Drainage Characteristics of Capiphon Belt™ & Pipe™: Some Comparisons with Slotted Pipe with Sock

GreenAbility Pty Limited, P.O. Box 9, South Hobart, Tasmania 7004, Australia

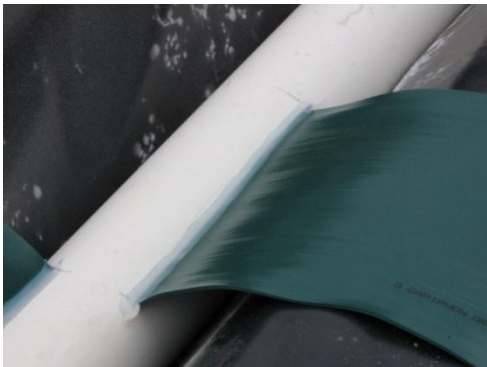
Figure 2. The Capiphon belt is usually inserted into a collection pipe laid some 10 cm below the level of the belt to increase the capillary head.

When the belt is below the water table, or when the belt is on a slope (usually 1-2%), the critical capillary head is exceeded and causes the capillary straw within the groove to move down the belt. The movement of the capillary straw within the grooves creates a negative pressure that sucks up water from the soil. This siphoning effect continues to drain the soil for as long as there is an effective capillary straw within the soil.

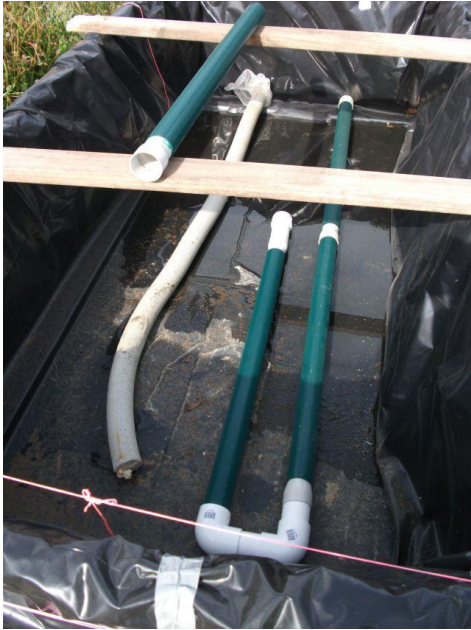
The frame of the tank was constructed from 45 mm timber. Figure 1a shows the tank and fittings. PVC couplings were used to connect the one metre lengths of Capiphon pipe. Right-angled couplings enabled up to four lengths to be tested. The timber frame set the level at which the pipes/belt passed through the end of the tank at 45 mm above the base (Figure 1b). Relative head is measured from zero at the top of the bottom frame. Figure 1c shows that there can still be water in the tank at a head less than zero.

The study was conducted in a wooden tank - approximately 2.4 m long, 1.2 m wide and 0.6 m high - lined with plastic sheeting to prevent leakage. The tank was carefully positioned to ensure that it remained horizontal across the tank, and on a 1-2% slope along its length. The position of the tank was checked twice during the trials to ensure that there had been no movement.

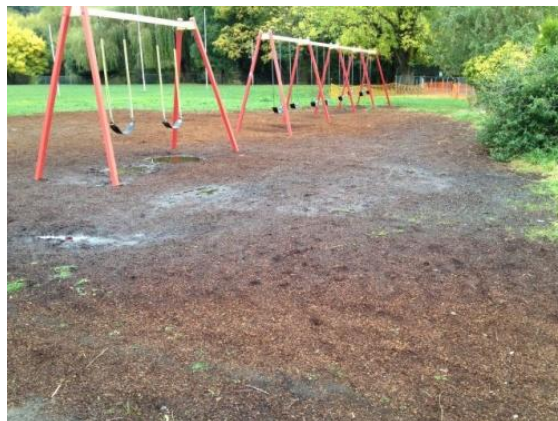
The playground at a local primary school has suffered from poor drainage for many years. It has a soft-fall layer of shredded bark, specified to be at least 30 cm deep. The soil underneath the soft-fall was “fill” with a high proportion of clay. The site was on a slight slope. The photograph (Figure 2) was taken some 48 hours after a 2.4 mm rain event, preceded by 10.6 mm a week earlier, and 5.6 mm two weeks before that.

Figure 2. Playground with persistent flooding.

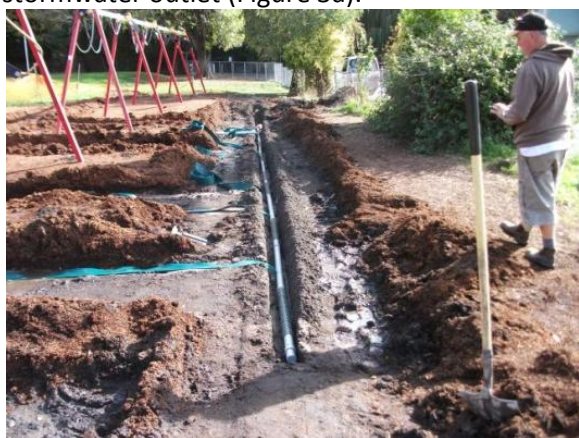
Figure 3a

The soft-fall was scraped back and 15 m lengths of Capiphon belt laid on a sprinkling of medium sand directly on the underlying soil between the swings. The space between the belts varied from one to two metres, and was determined by avoiding the swing supports and the depressions directly under the swings. The belt was inserted into a 50 mm OD PVC/Capiphon pipe lying in a narrow trench approximately 100 mm deep. The pipe led to a sump at which flow rate measurements could be made, before being pumped to the stormwater outlet (Figure 3a).

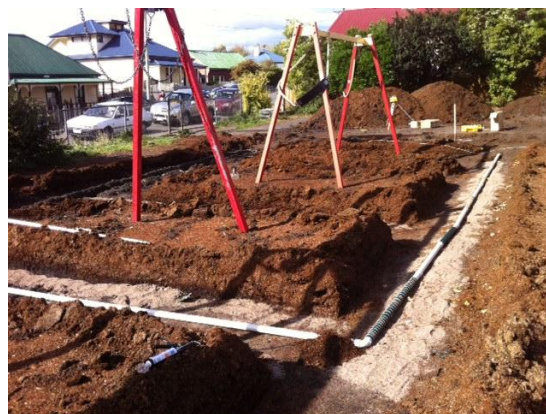
Figure 3b

A second combined Capiphon (green) and PVC (white) pipe was laid on the upside of the swings to capture water coming down from the playing field above (Figure 3b).

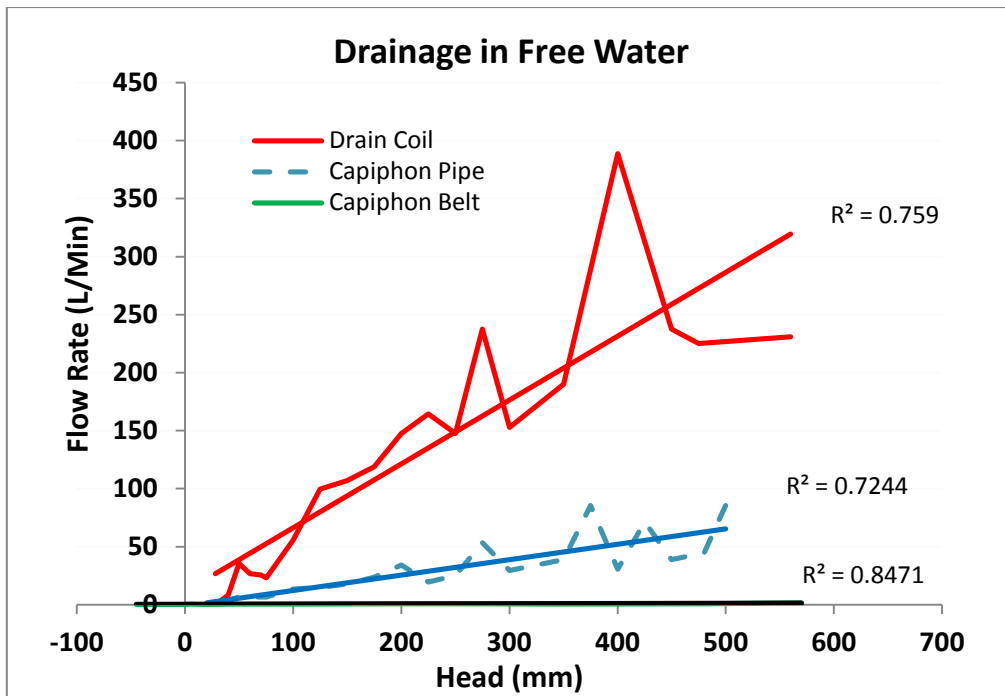
Figure 5a shows the decreasing flow rate of all three technologies with decreasing head. It is obvious that Drain Coil had a higher flow rate than Capiphon belt until the head dropped to about 22 mm. Drain Coil ceased to flow, in fact, when the head was still around 20 mm (Figure 5b). Capiphon belt continued to flow until -45 mm, illustrating the effect of capillary action and siphoning. The Capiphon pipe continued to drain to -5 mm. All measurements of head were taken from the outlets resting on the timber frame (relative zero).

Figure 5a Decreasing flow rate of Drain Coil, Capiphon pipe, and Capiphon belt in water as the tank emptied.

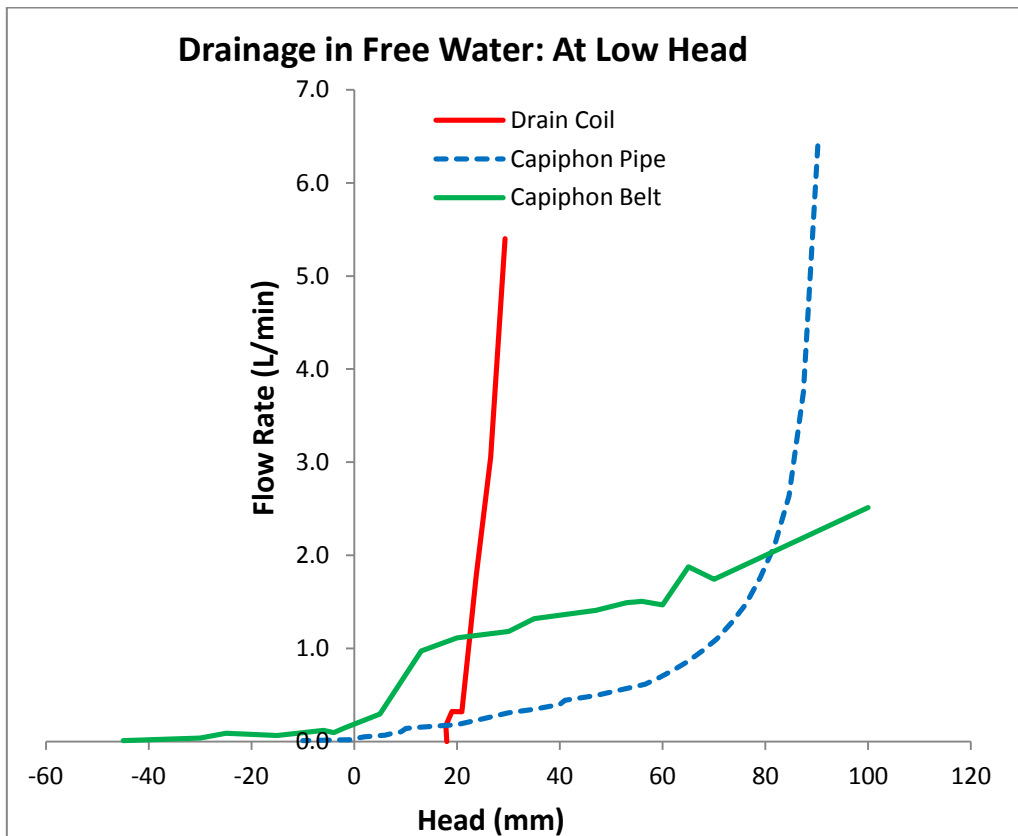
Figure 5b. Detail from Figure 5a. A negative head indicates drainage continues below the outlets.

The Drain Coil, Capiphon belt and Capiphon pipe were the same length – 2 metres. Flow rate within a pipe decreases with length due to friction losses. The rationale underpinning the pipe version of Capiphon is that water flowing inside the grooves moves into the inside of the PVC pipe, thus limiting the head loss in the grooves. The pipe form of Capiphon would therefore be expected to have a higher flow rate than the belt for more than one metre. This is borne out by the results in the Figure 5b, at least until the head falls to

around 80 mm, at which time the siphoning effect has overtaken gravitational mass flow as the dominant force. The fact that the flow rate increases uniformly with the number of lengths of Capiphon pipe, as shown in Figure 6 is consistent.

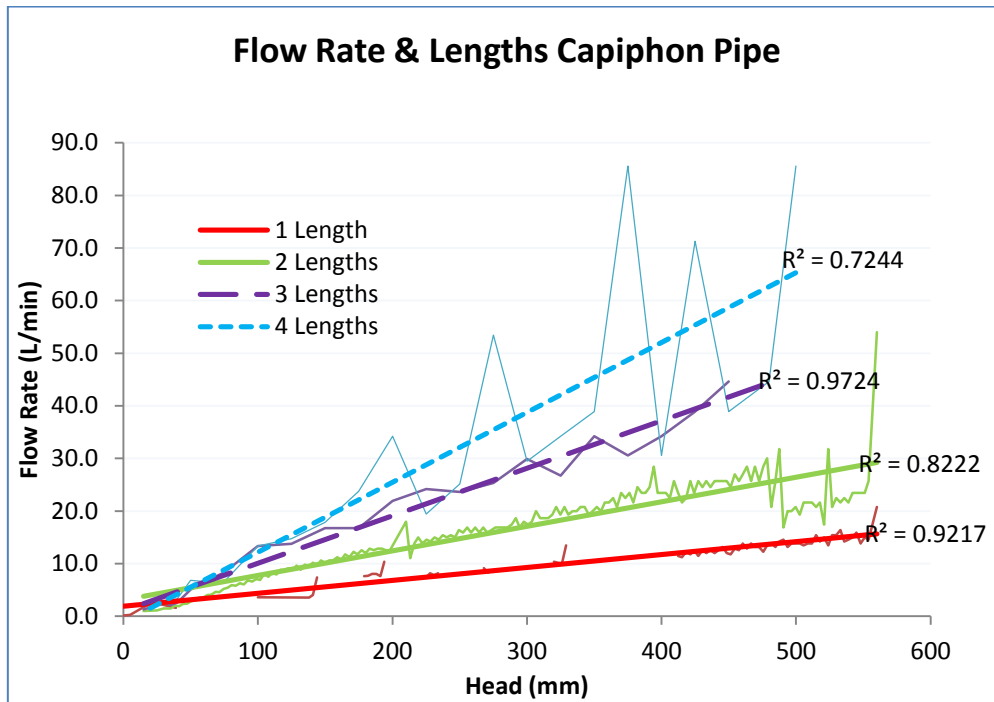
Figure 6. The effect of the number of one metre lengths on flow rate of Capiphon pipe in water.

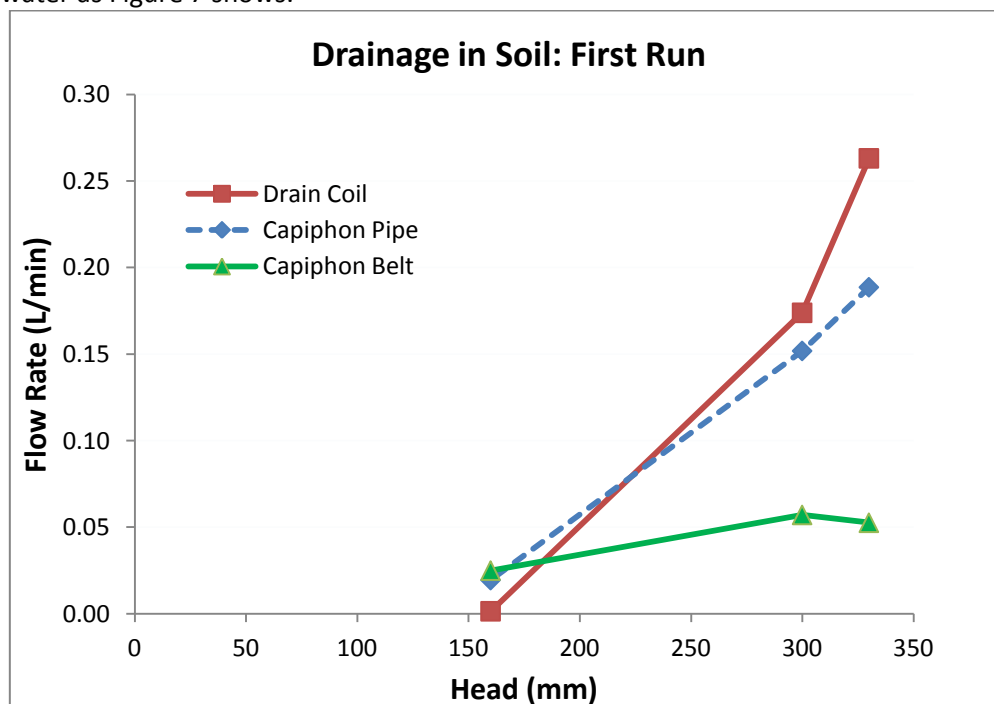
The comparative advantage of Drain Coil over Capiphon at high head disappears when the medium is soil rather than water as Figure 7 shows.

Note that the flow rate of both Drain Coil and Capiphon pipe have decreased by a factor of 1000, whereas the flow rate of the belt is only 1/10th of that in free water. This would indicate that the permeability of the soil is limiting flow rate, rather than the drainage method itself.

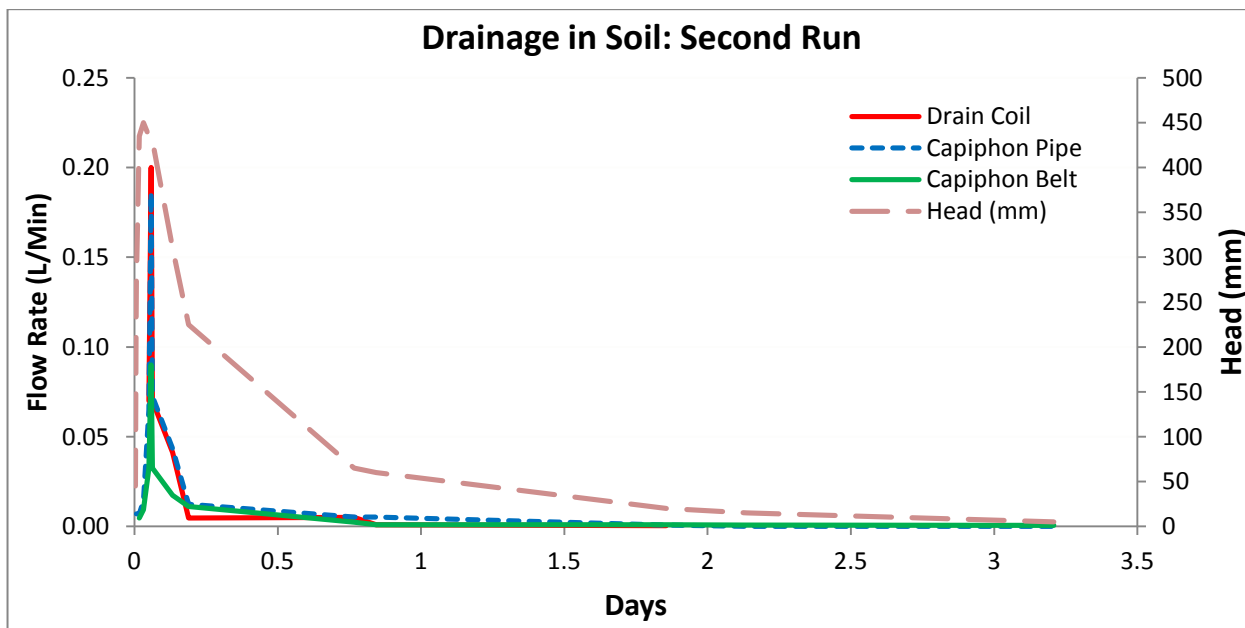
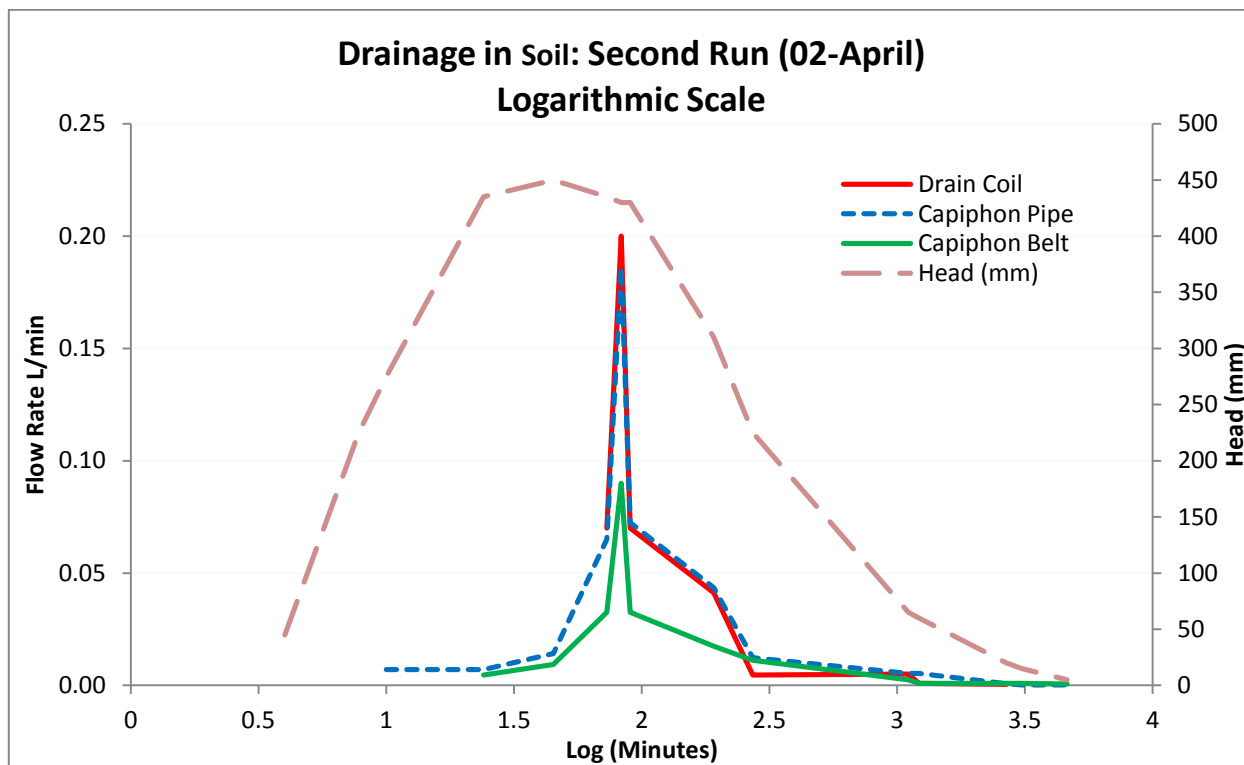
The flooding event was repeated after turf had been laid on top of the soil. Figure 8a shows that the head rose rapidly then fell as first the Capiphon pipe, then the belt and, lastly, the Drain Coil started to flow. Figure 8b uses a logarithmic scale (Log{minutes}) to better illustrate the responses.

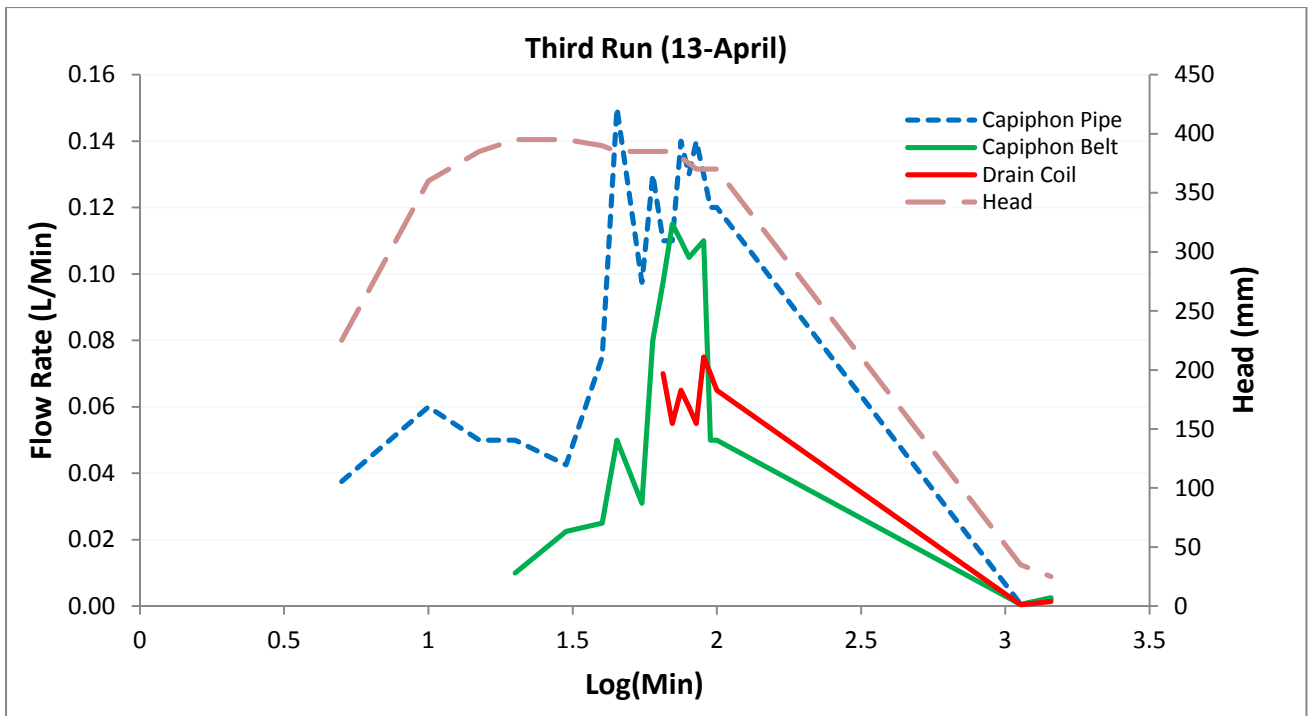
The third flooding event clearly illustrates speed at which both Capiphon pipe and Capiphon belt begin to drain the tank (Figure 9). Table 1 shows how long it took each to start to flow.

Figure 9. Flow rates after the third flooding event in soil – logarithmic scale.

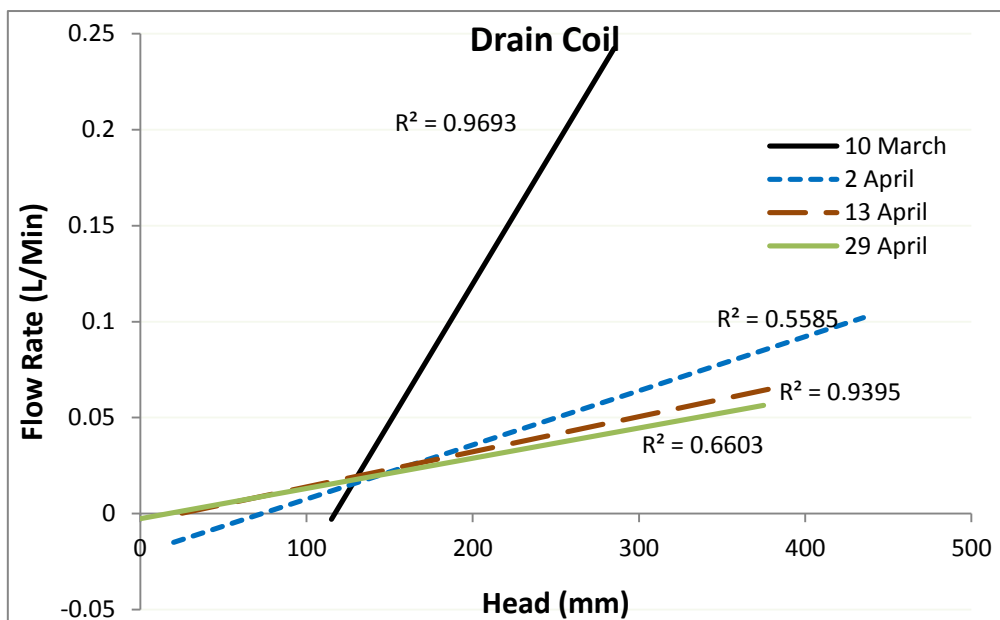
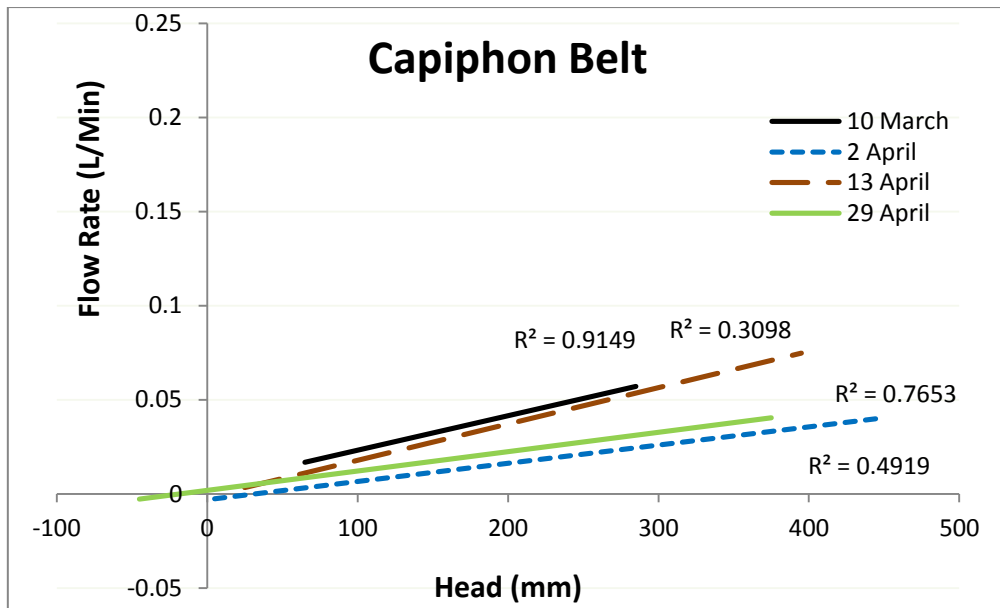
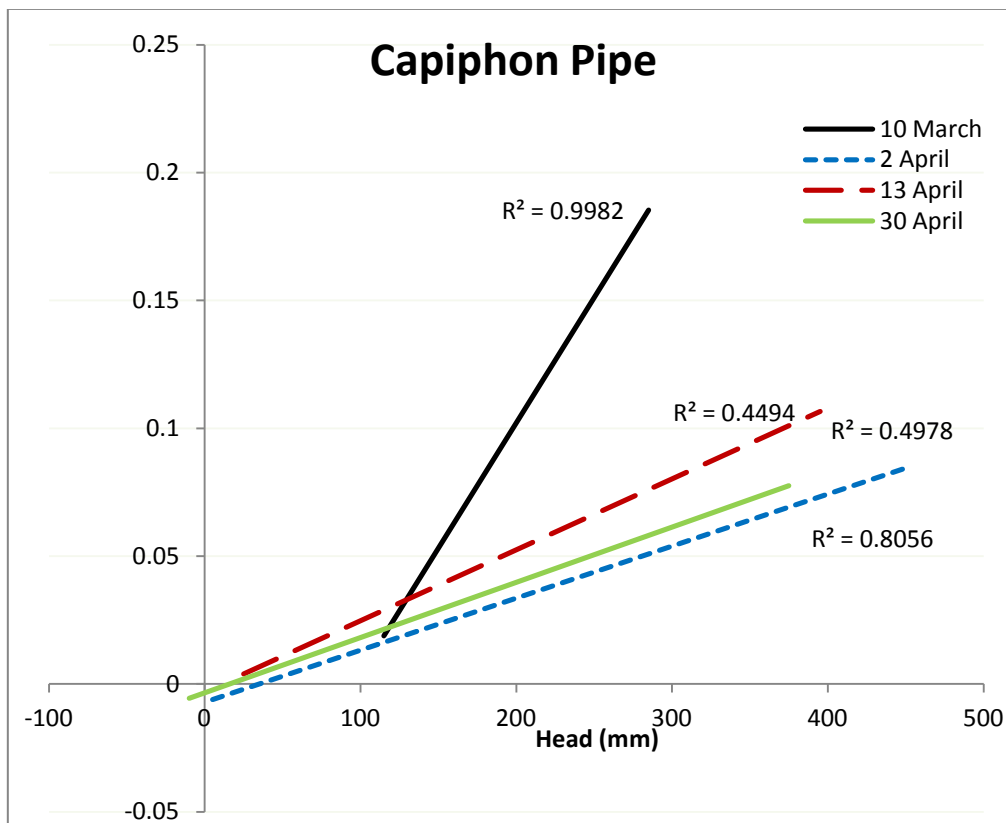
It was apparent that the flow rate of Drain Coil slowed with successive flooding and rain events, probably because the cloth surrounding it becomes progressively blocked. On the other hand Capiphon belt appeared to improve its performance, perhaps because silt had been displaced to make the capillary straws within the soil more effective (Figures 11 a, b, and c). Water flow into and out of Capiphon grooves is laminar (Reynolds Number of 100 to 600, Sileshi et al., 2010b) and therefore carries less sediment. This would, in turn, result in Capiphon being less prone to clogging.

Figure 11a. Flow rate decline over time: Drain Coil

Figure 11b. Flow rate decline over time: Capiphon belt

Figure 11c. Flow rate decline over time: Capiphon belt

The decline in performance of the Drain Coil is most likely associated with occlusion of the sock by fine soil particles. The manufacturers of Capiphon have long claimed that their product does not block (some installations draining over 15 years). These studies lend support to that claim.

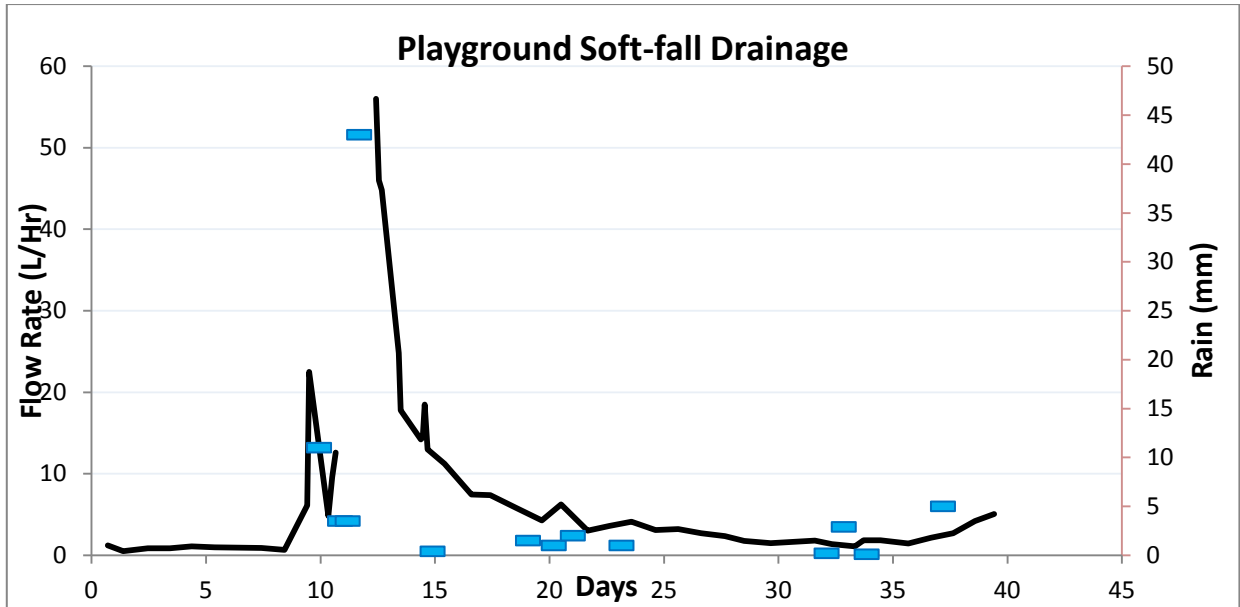
The combined Capiphon belt/pipe system (under the swings Figure 3) began to flow almost immediately it had been connected to the pit, although the Capiphon pipe alone (Figure 4) did not begin to flow until a significant rain event. Figure 12 shows the flow rate, along with rainfall, over the ensuing 30 days.

Figure 12. Drainage over 30 day period. Covers several rain events including one of 43 mm.

It is apparent that the flow rate through the system(s) closely mirrors, and in fact responds to, the rain falling on the playground. The gap in the chart is due to the inability to measure the accumulated flow because the water overflowed the sump.

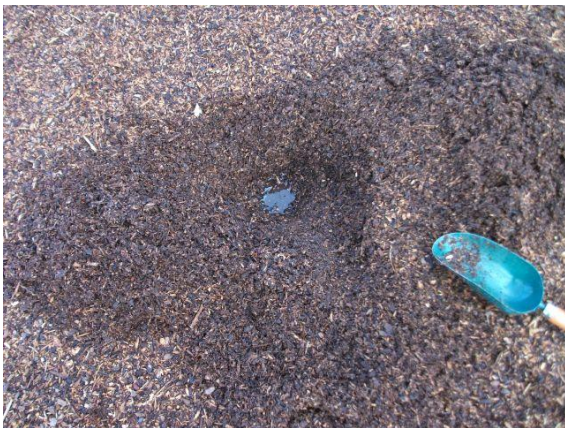
Figure 13a. A shallow hole under the swings area that had not been drained shows free water just below the surface.

Despite the heavy downpour, Capiphon so effectively drained the playground that it could be used immediately afterwards (Figures 13a, 13b, 14). The drainage was active from both the Capiphon pipe and the Capiphon belt systems on that occasion (Figure 15).

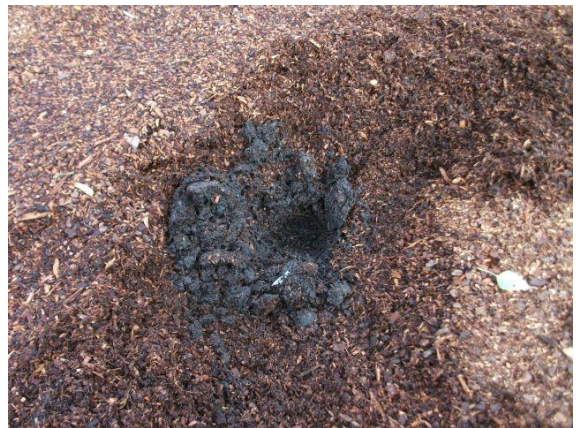
Figure 13b. A deeper hole under the swings in the drained area shows no sign of free water.

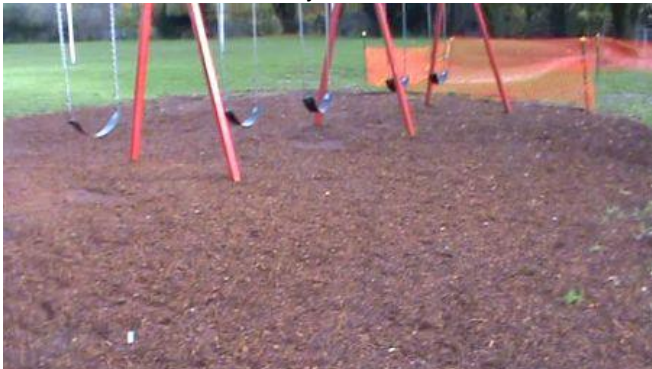
Figure 14. The playground some two hours after the 43 mm rain event ceased.

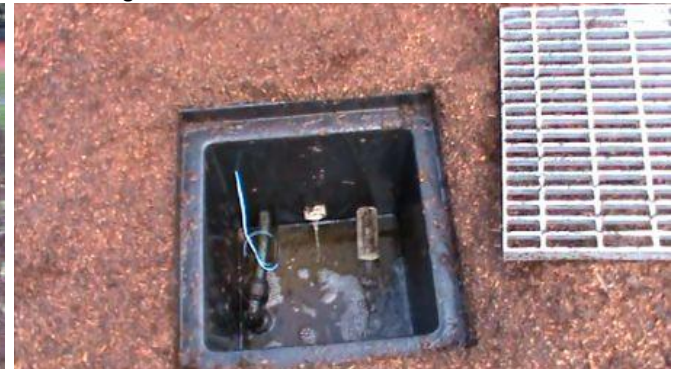
Figure 15. Water flowing from the Capiphon pipe system (left) and the belt system (right) two hours after the rain.
