A NEW AND MORE COST-EFFECTIVE DRAINAGE SYSTEM FOR TURF: A COMPARATIVE TRIAL IN A RACETRACK

Geoffrey Fenn¹

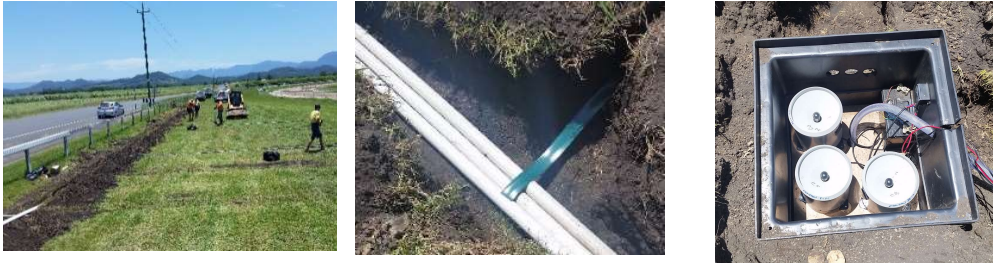
Given the minimal fall on the track, and the lack of a suitable site for the flow gauges, a sump pit was constructed at a depth below ground level at the edge of the track where the outflows were measured in three separate tipping bucket flow gauges (40ml buckets)..
